NIST Special Publication 901

The January 17, 1995 Hyogoken-Nanbu (Kobe) Earthquake

*Performance of Structures, Lifelines, and Fire
Protection Systems*

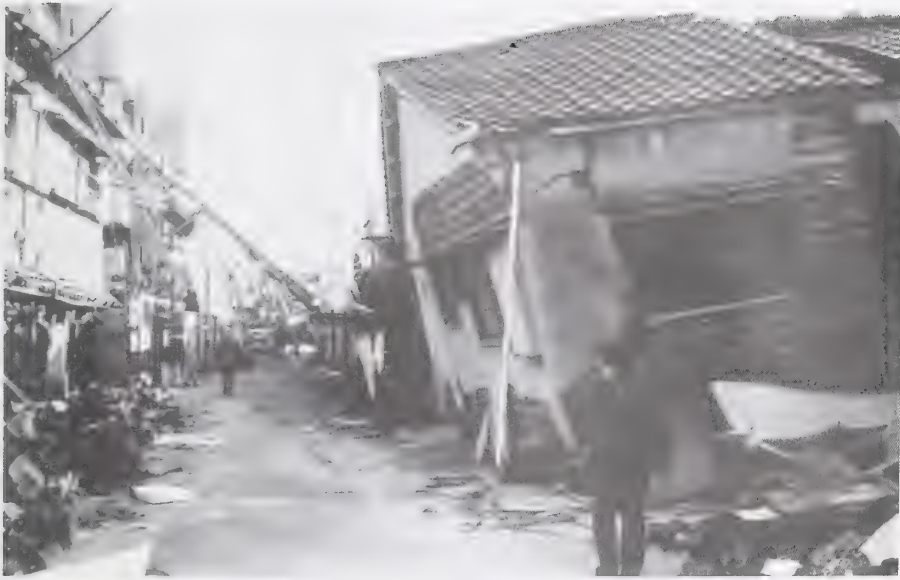
The number of collapsed houses constituted about 10 percent of the houses in the Kobe area. It was reported [3] that nearly 55000 houses collapsed and over 35000 houses were partially destroyed. These included both Shinkabe and Ohkabe houses. Typical damaged houses are shown in Figures 3.3.1 and 3.3.2.

Figure 3.3.1 A collapsed Ohkabe construction-type house.

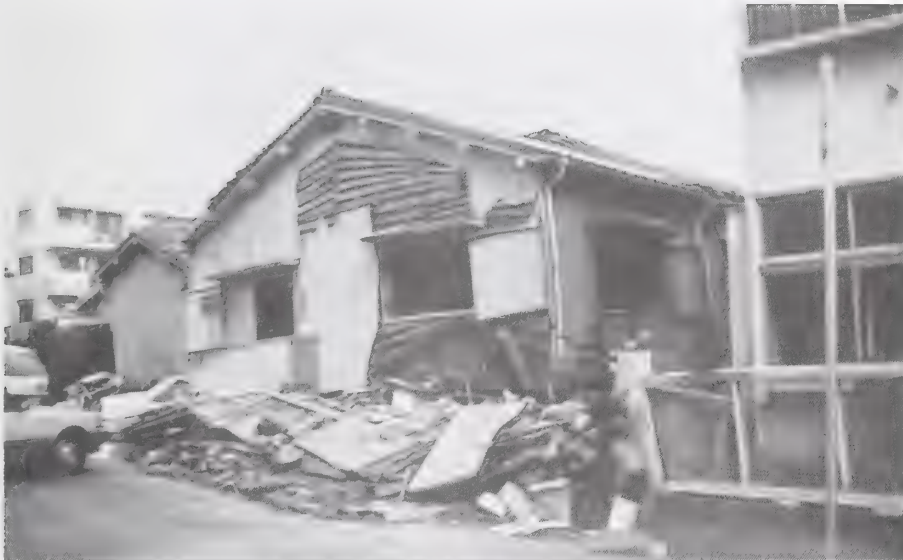
Figure 3.3.2 Same as Figure 3.3.1.

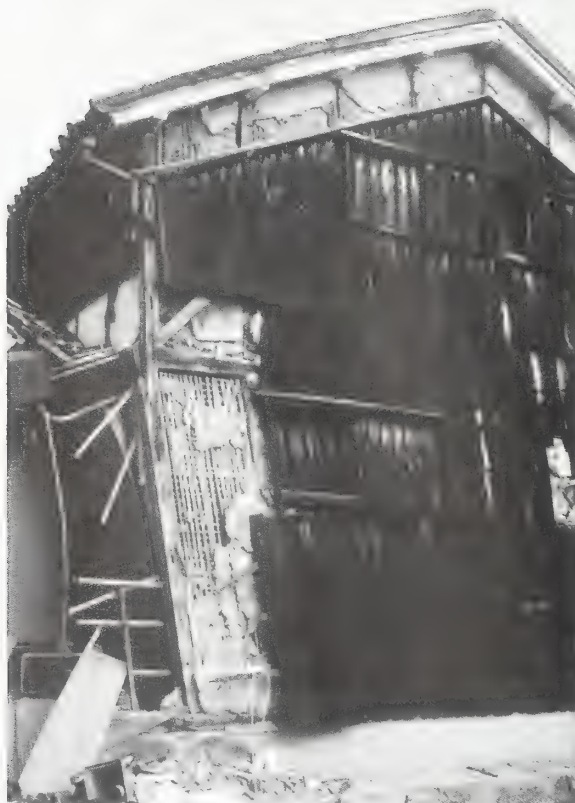
In general, more Shinkabe houses sustained complete collapse. The Shinkabe construction employed walls of bamboo thatch tied with rope and packed with mud. The outside facade consisted of stucco or some light coverings with no structural resistance. Figure 3.3.3 shows a damaged two-story Shinkabe construction and Figure 3.3.4 shows a completely collapsed Shinkabe house. In Ohkabe construction, the columns were joined by thin wooden slats (80 mm x 20 mm) placed horizontally (see Figure 3.3.5). Some parts of the Ohkabe houses were also reinforced by light wooden cross braces, and they performed better than the unbraced parts (see Figure 3.3.6). There were no indications of plywood or particle-board shearwalls being used in these constructions, as is a common practice in the United States. Only a few wood houses had some type of diagonal bracings, and a majority of the wood houses had essentially no significant lateral load carrying capacity to withstand earthquake loads.

Figure 3.3.3 A damaged two-story Sake factory with Shinkabe construction.

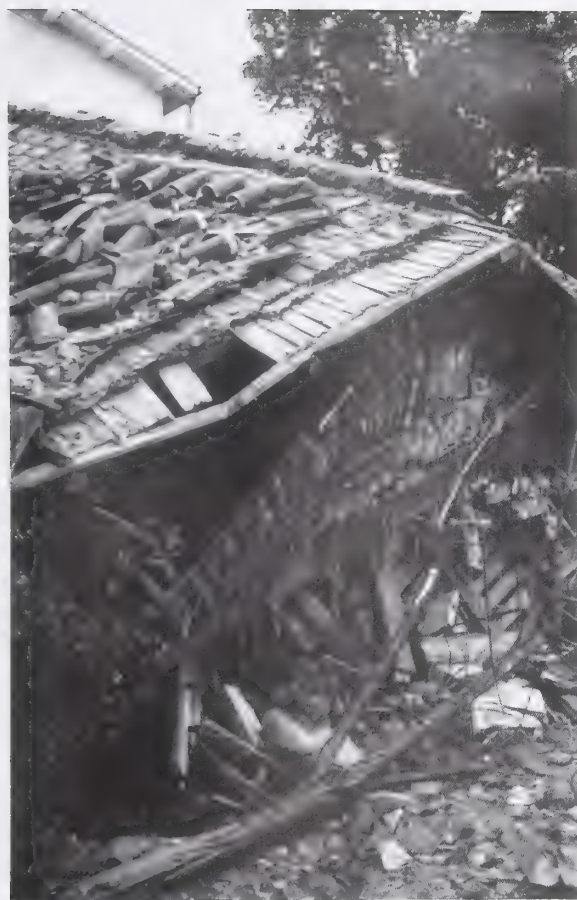
Figure 3.3.4 A completed collapsed Shinkabe construction-type house.

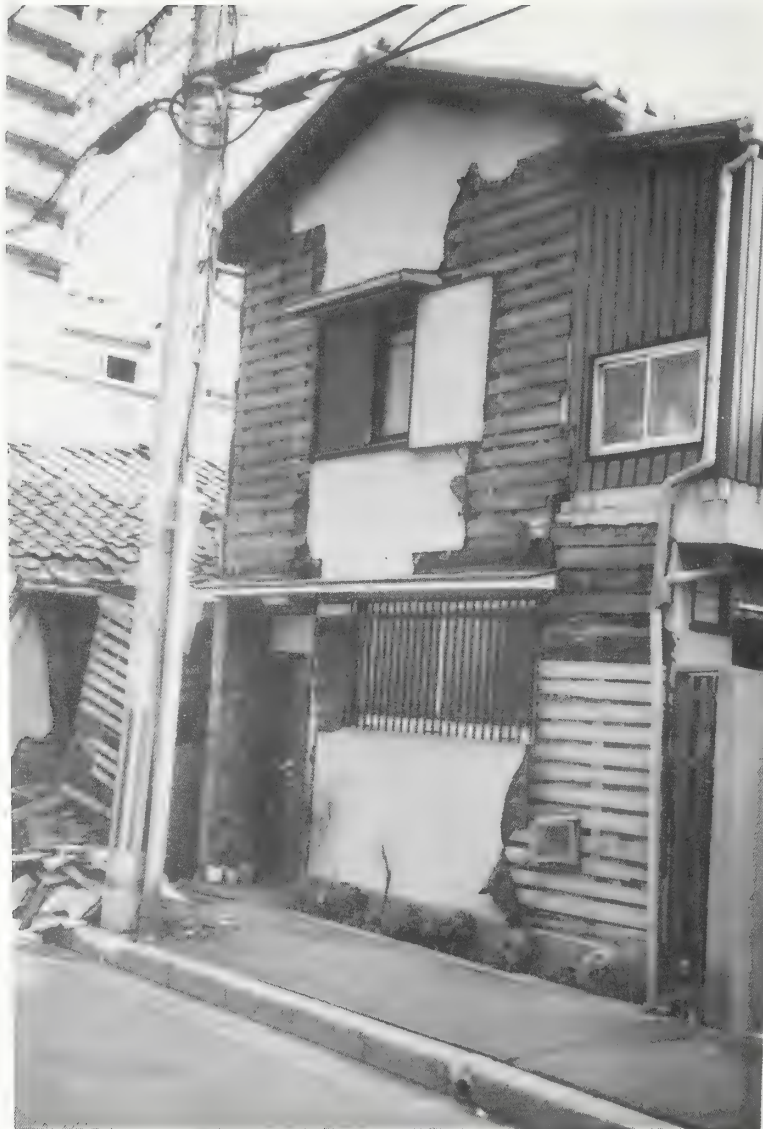
Figure 3.3.5 An Ohkabe house with only architectural design. Note a shadow of diagonal bracing on the left side of second story.

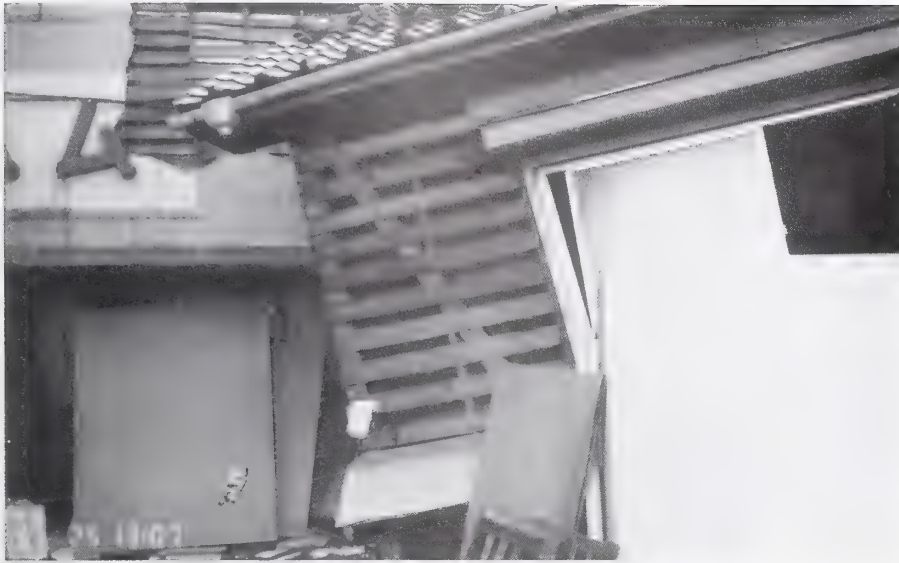
Figure 3.3.6 Intact upper story (braced) of a collapsed unit - Ohkabe construction.

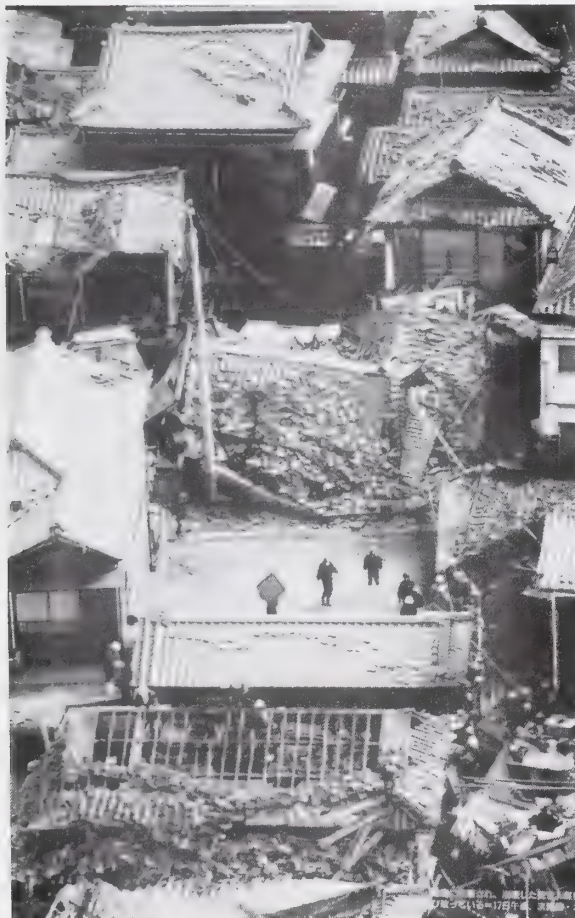
Many severely damaged houses had heavy ceramic roof tiles set on soil as bedding (see Figure 3.3.7). It is believed that heavy tiled roofs were preferred not only for the aesthetic and architectural reasons, but also because they could not be easily dislodged by gusty winds in a typhoon. The heavy roofs of these houses have contributed a great deal to their collapse. On the other hand, some of the older houses which used less elaborate and less expensive synthetic roofing made of light material performed well in this earthquake.

Figure 3.3.7 Collapse of some heavy tiled roof houses - Shinkabe construction,

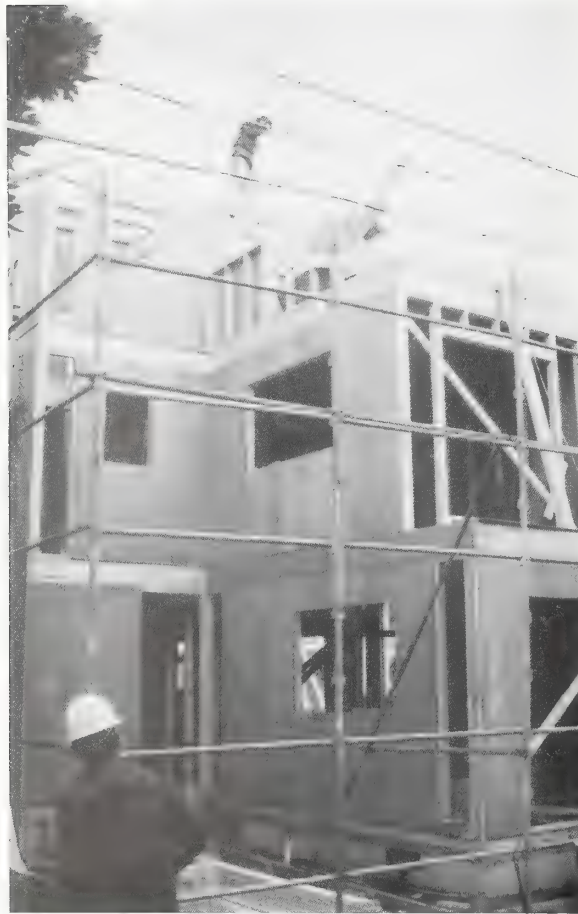
construction and the residential houses which followed the 1971 and later code regulations performed rather well in this earthquake. Figure 3.3.8 shows a frame house under construction using 2x4's which survived the earthquake.

Figure 3.3.8 A new "two-by-four" construction replacing a destroyed residential unit.

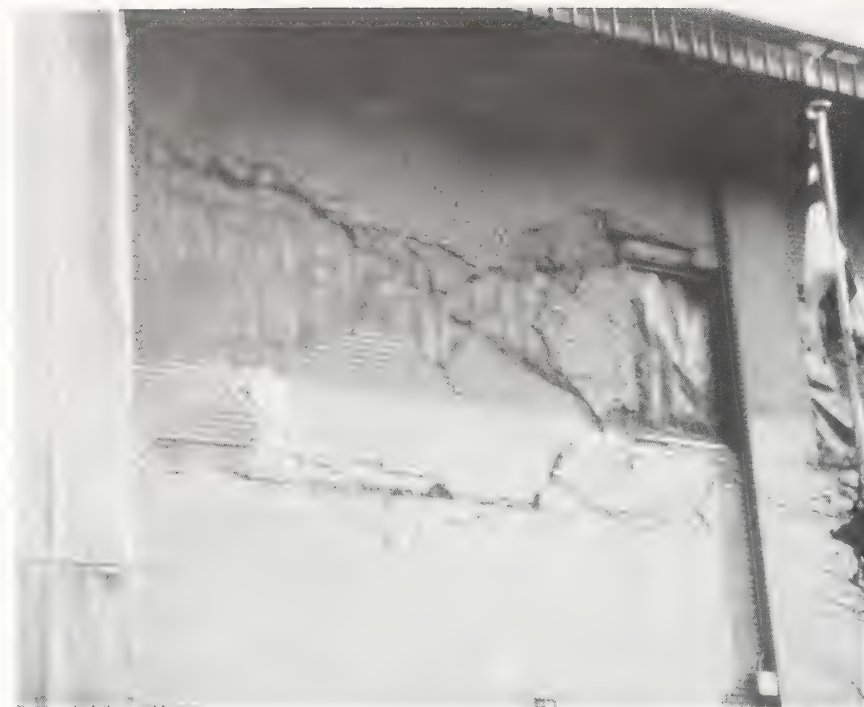
Figure 3.4.2 Damage to shear walls - Kobe Central Post Office.

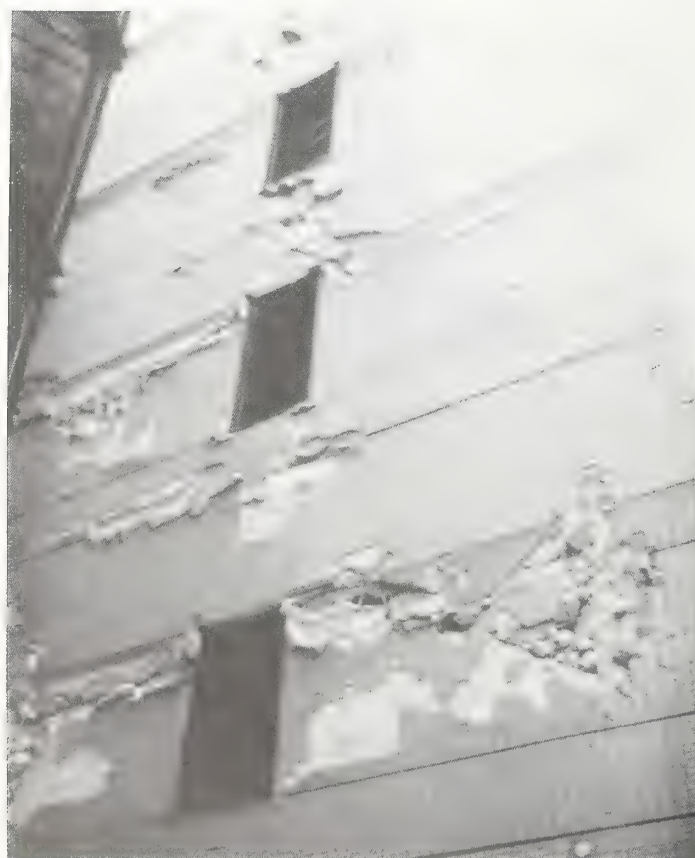
Figure 3.4.3 Damage to shear walls - office building in downtown Kobe.

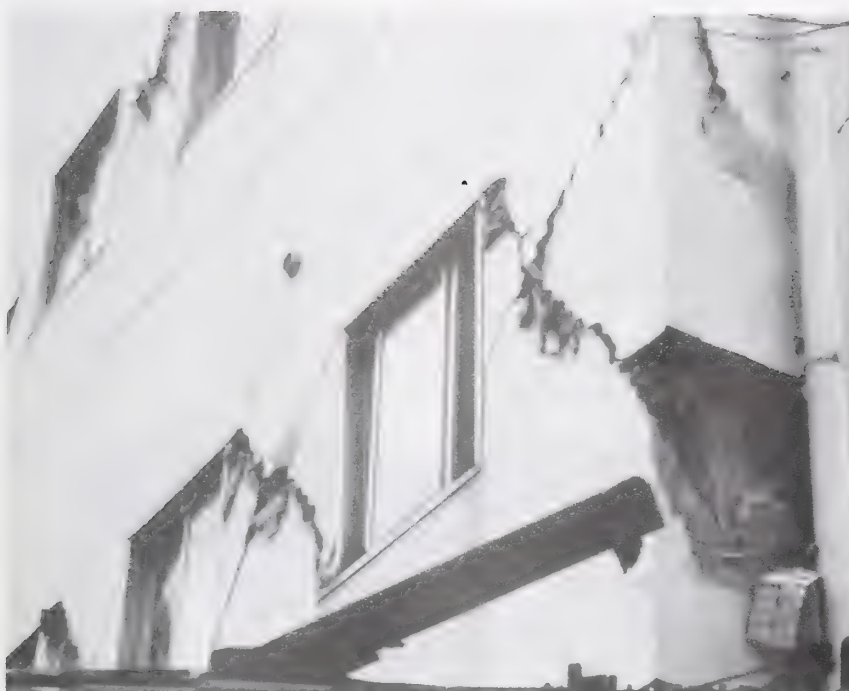
Figure 3.4.4 Diagonal tension cracks - apartment building in Nishinomiya area.

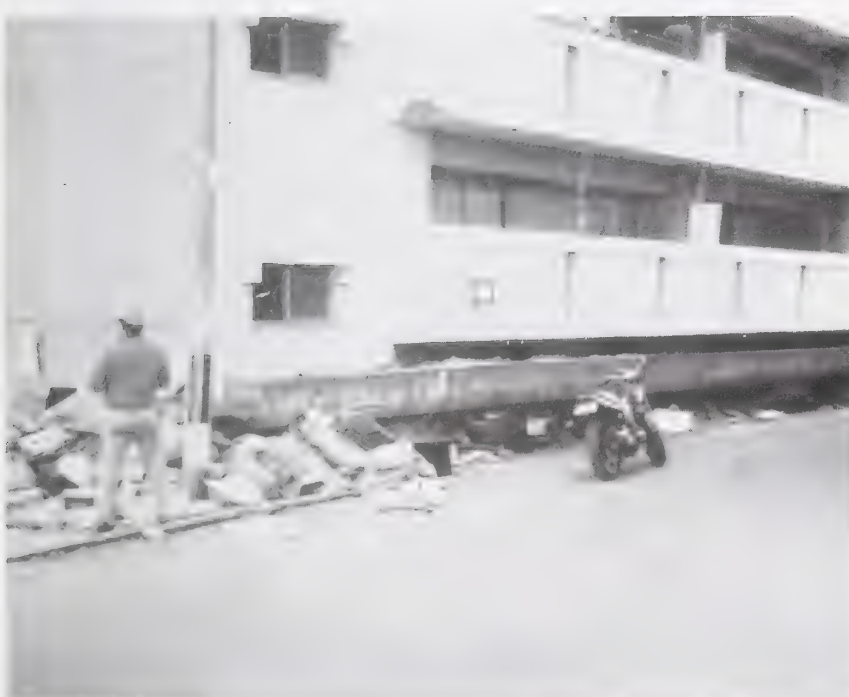
Figure 3.4.5 Failed ground floor shear wall - apartment building.

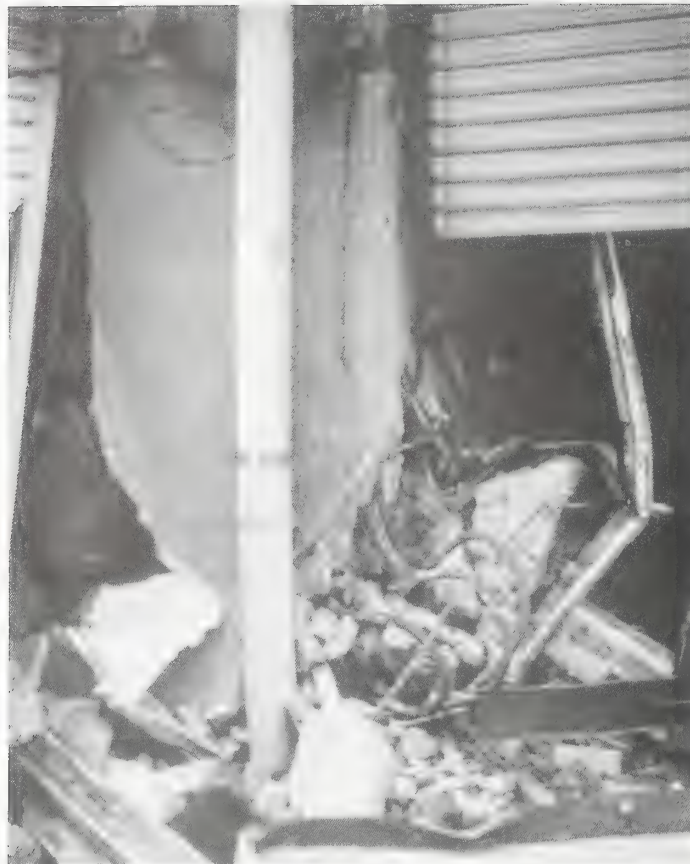
Figure 3.4.6 Failure of older column - local bar buckling.

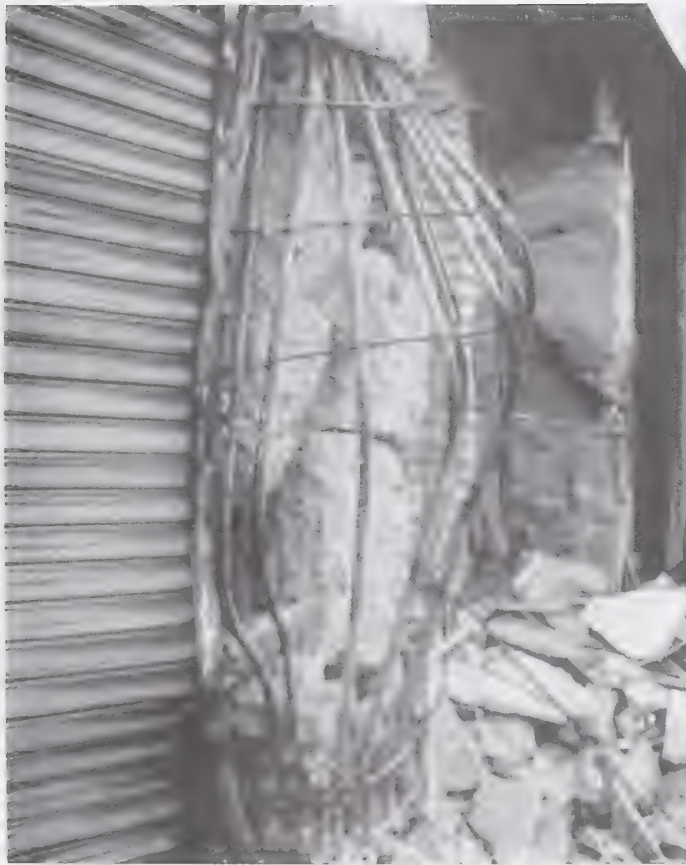
Figure 3.4.7 Failure of older column - general bar buckling.

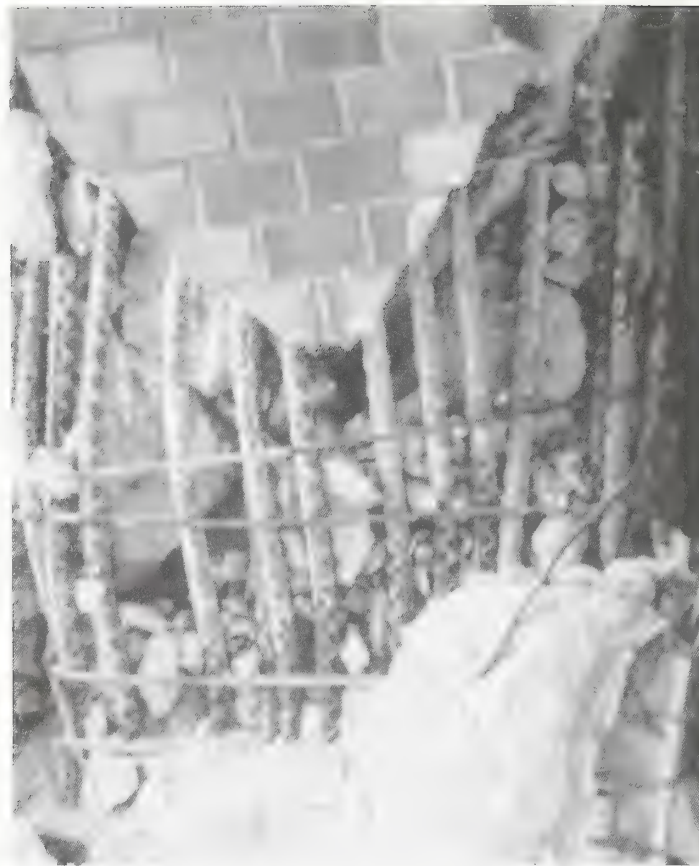
Figure 3.4.8 Failed column in commercial structure.

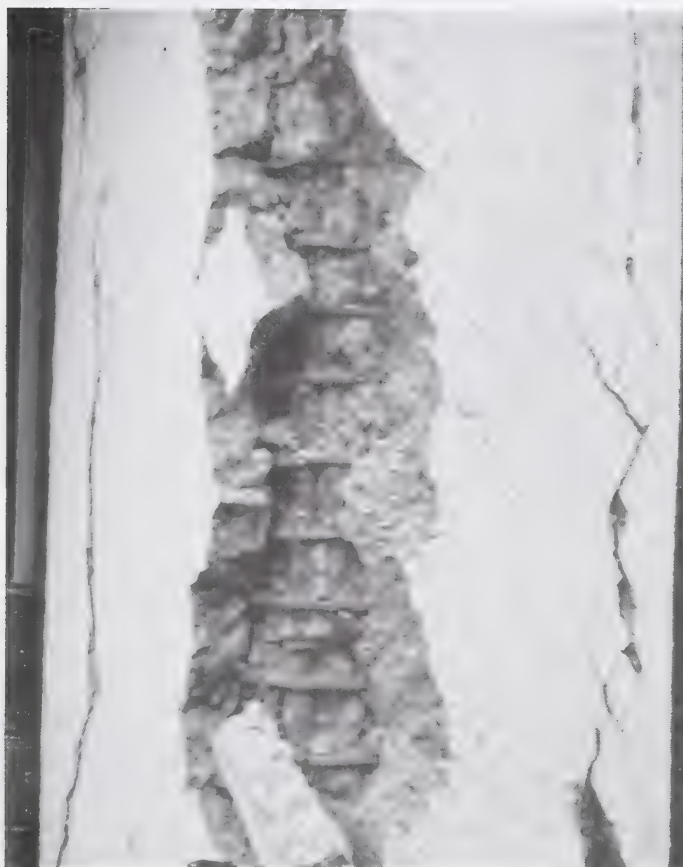
Figure 3.4.9 Damaged column in commercial structure.

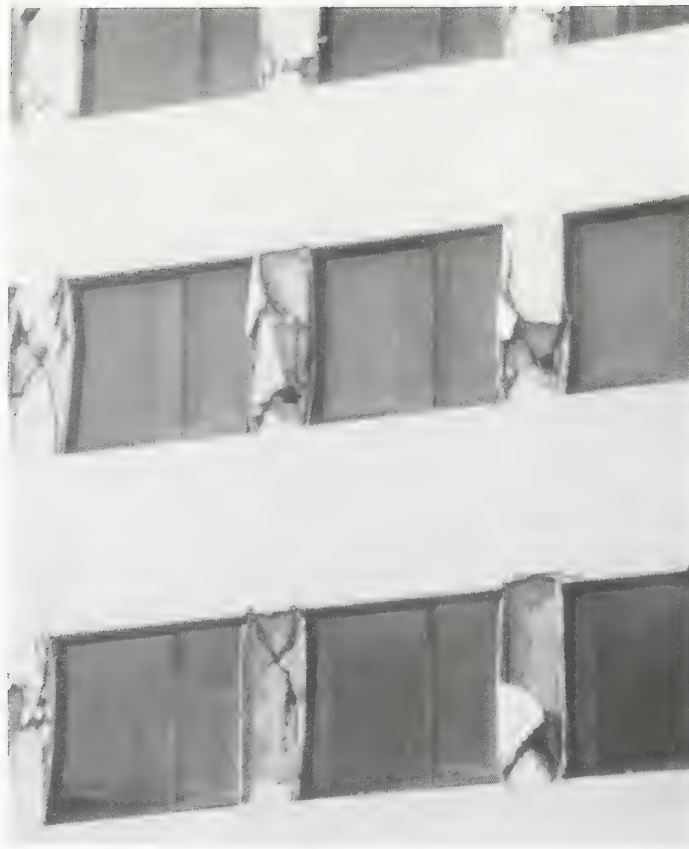
Figure 3.4.10 Short column effects - Otaki Building.

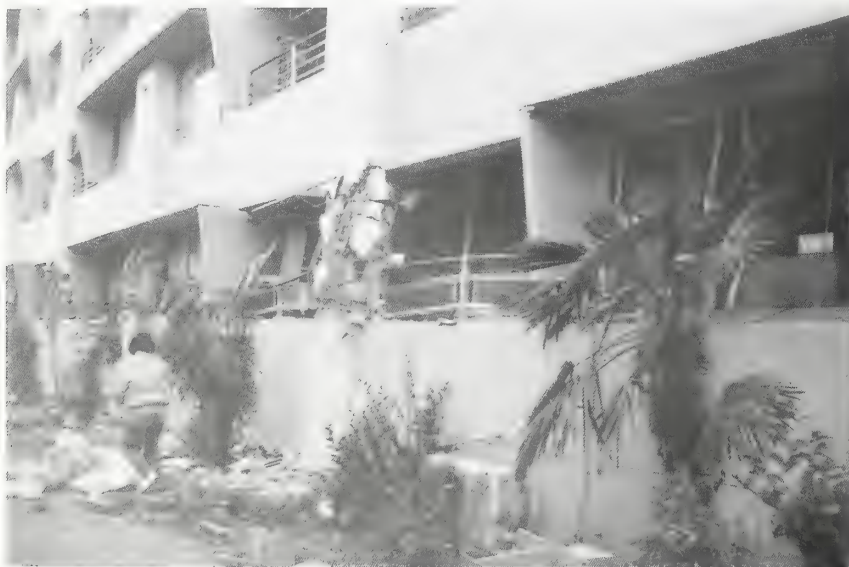
Figure 3.4.11 Short column effects - Fukae Mitsuku Housing Project.

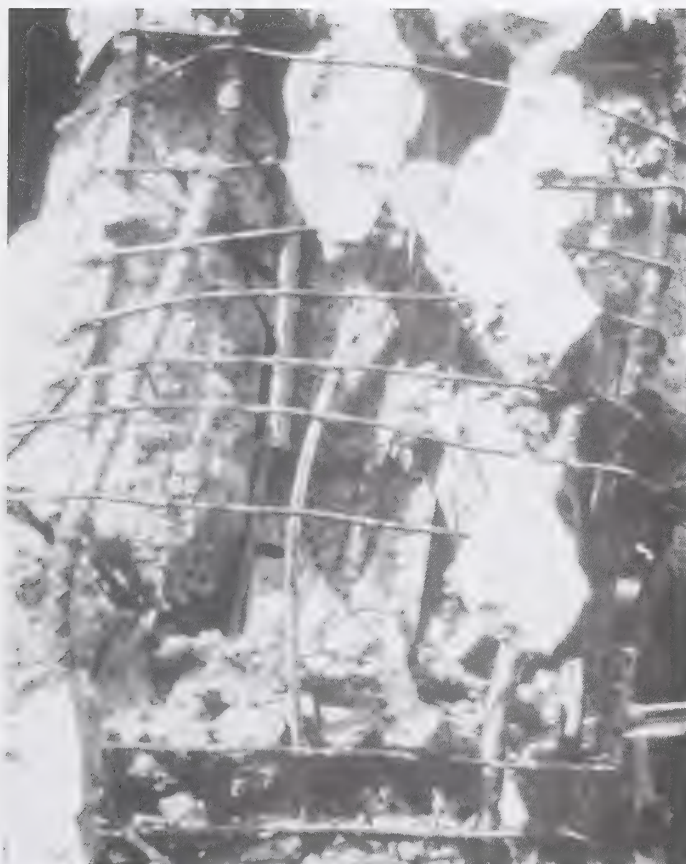
Figure 3.4.12 SRC column - Fukae Mitsuku Housing Project.

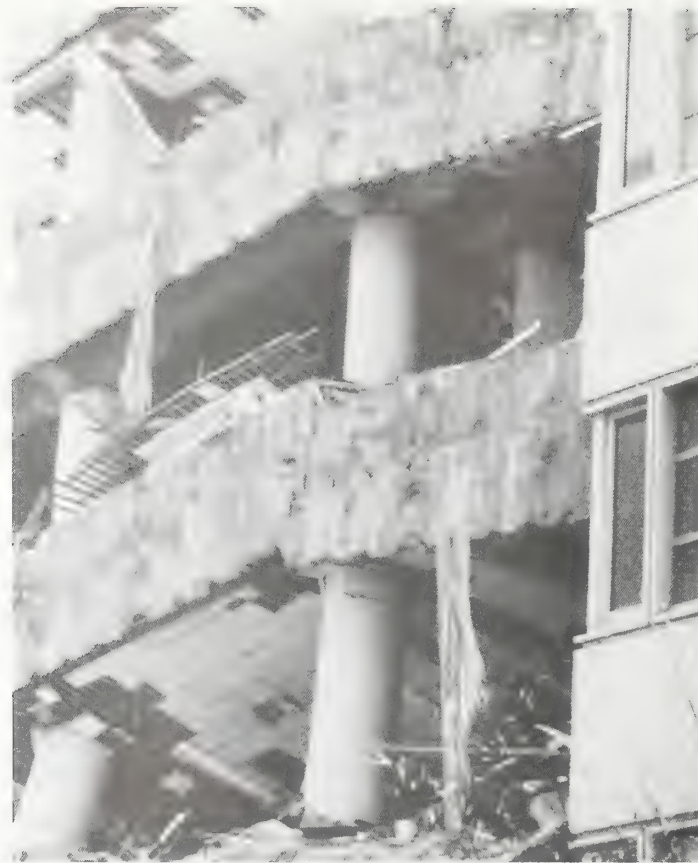
Figure 3.4.13 Strong beam-weak column failure.

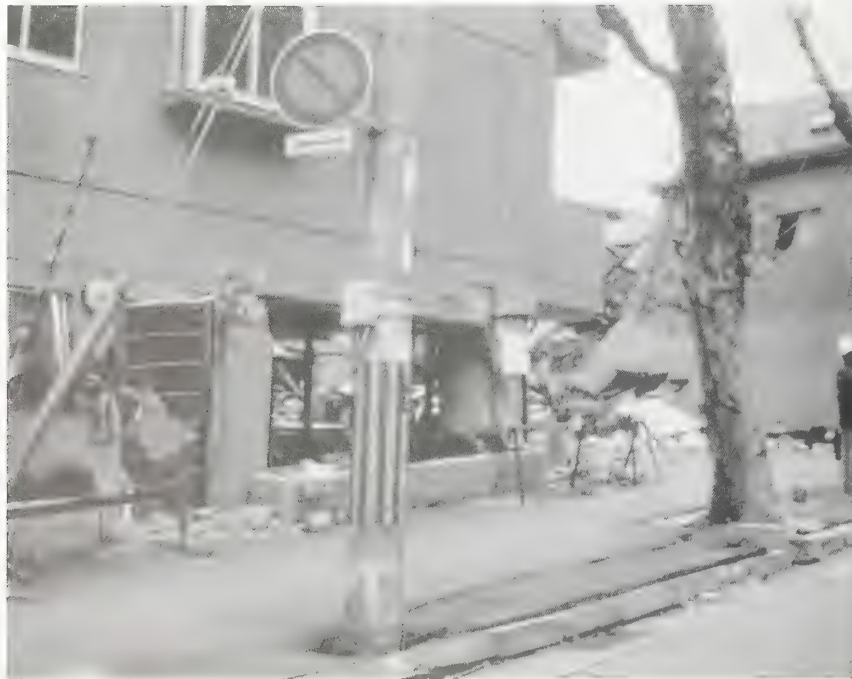
Figure 3.4.14 Collapsed first story near JR Line.

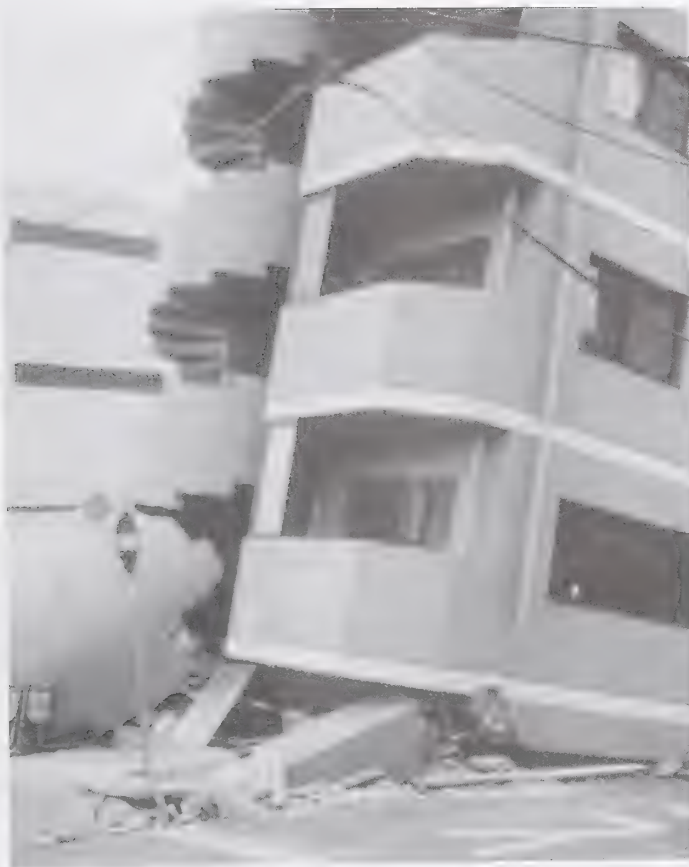
Figure 3.4.15 Collapsed first story.

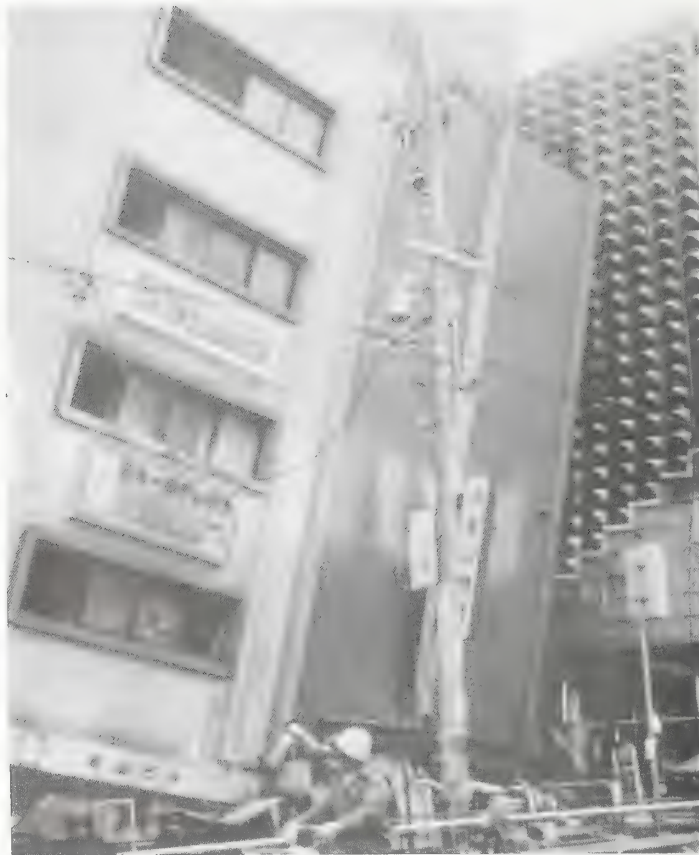
Figure 3.4.16 Collapsed first story - downtown Kobe.

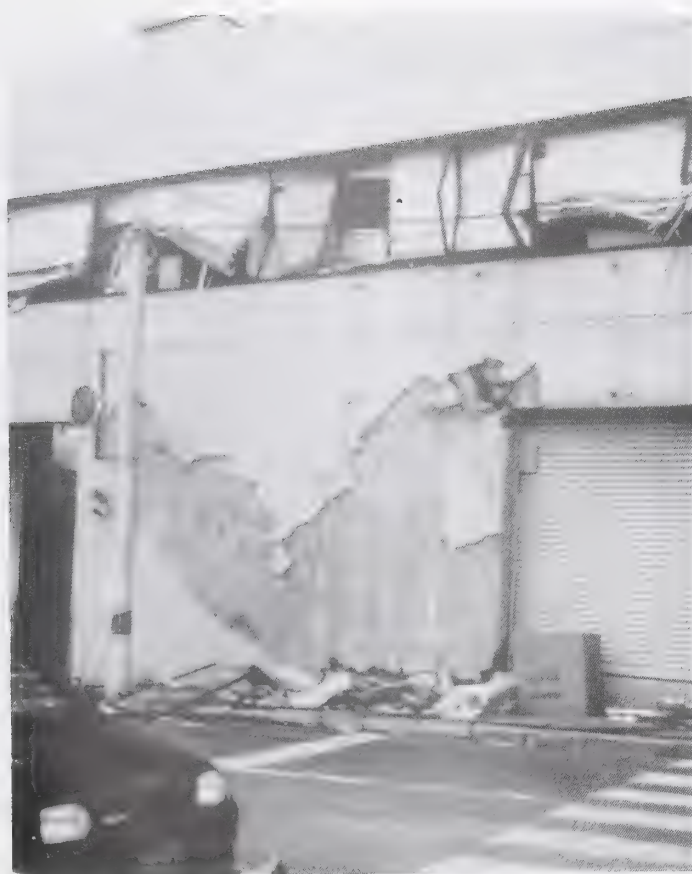
Figure 3.4.17 Second story collapse - Miyagi Hospital.

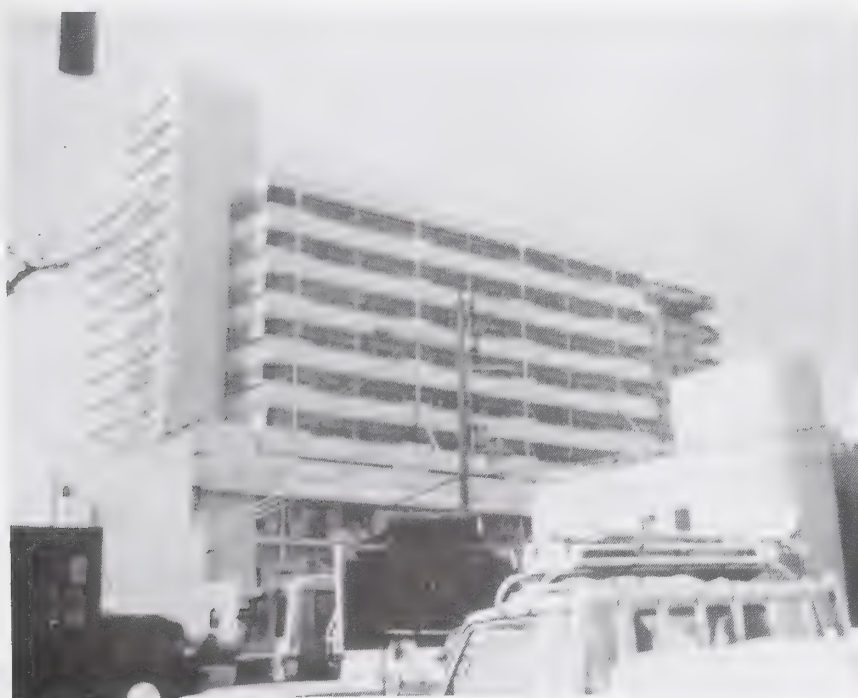
Figure 3.4.18 Fourth story collapse in apartment building.

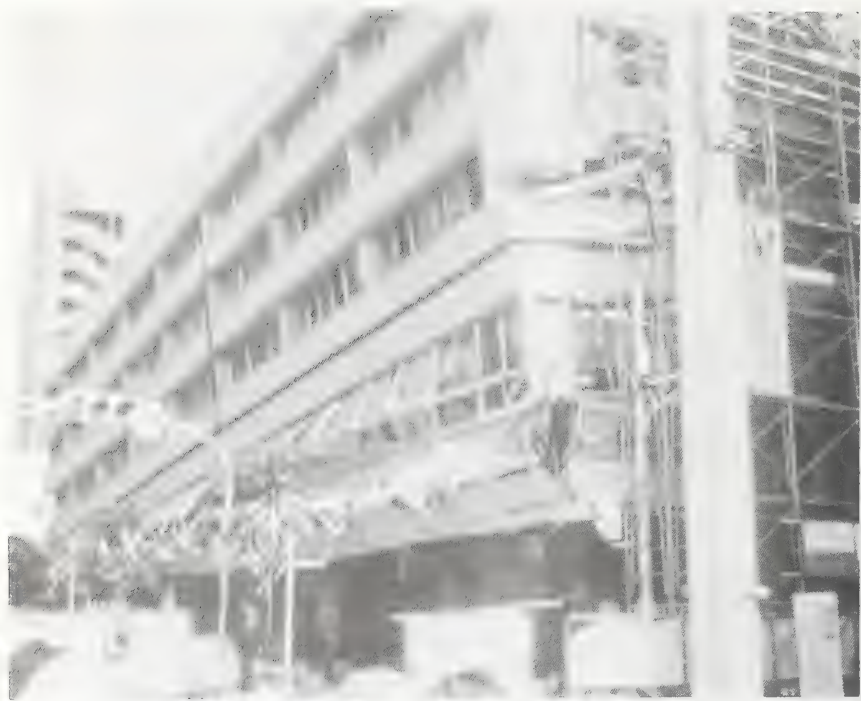
Figure 3.4.19 Second story collapse - Downtown Kobe.

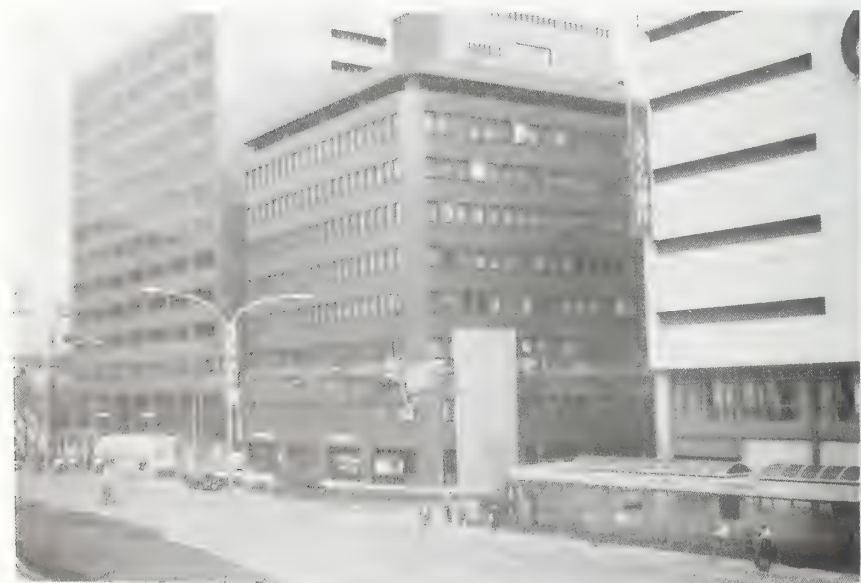
Figure 3.4.20 Third story collapse - Downtown Kobe.

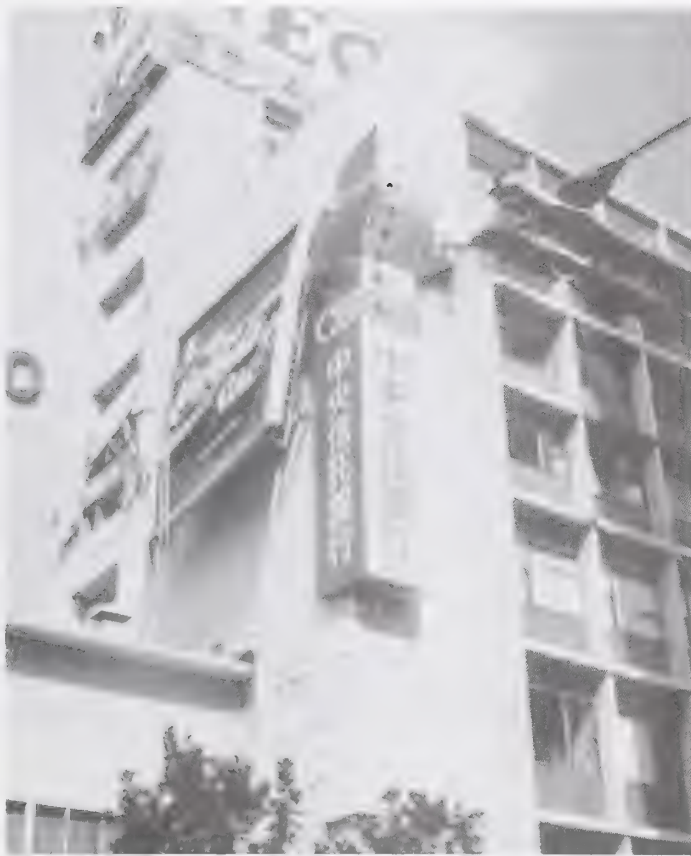
Figure 3.4.21 Upper story collapse - Downtown Kobe.

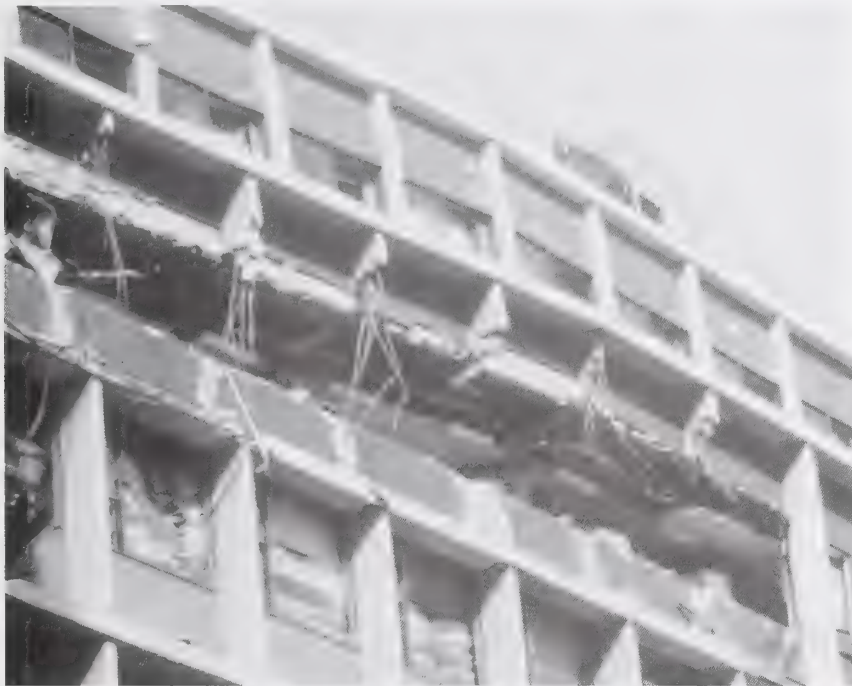
Figure 3.4.22 Upper story collapse - Downtown Kobe.

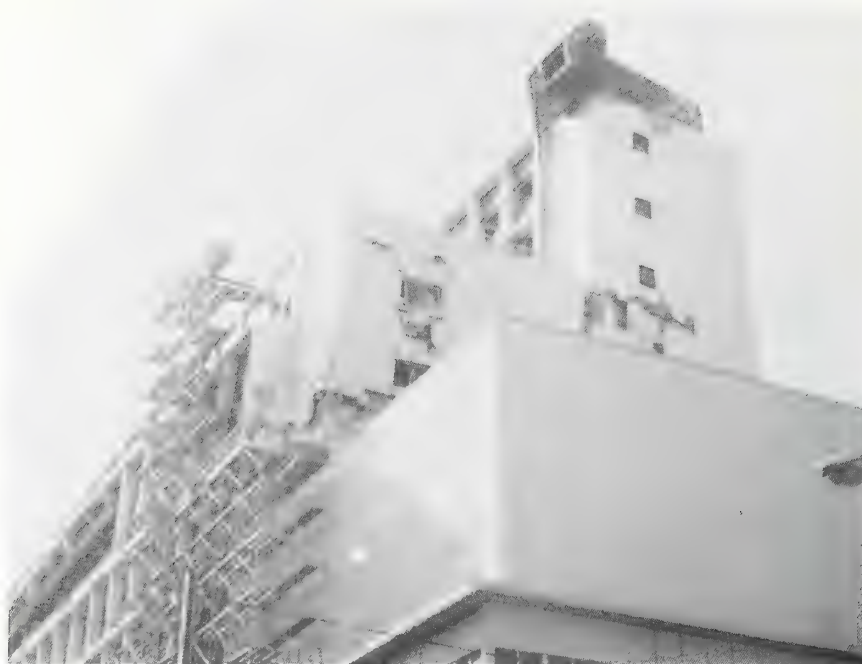
Figure 3.4.23 Collapsed penthouse structure.

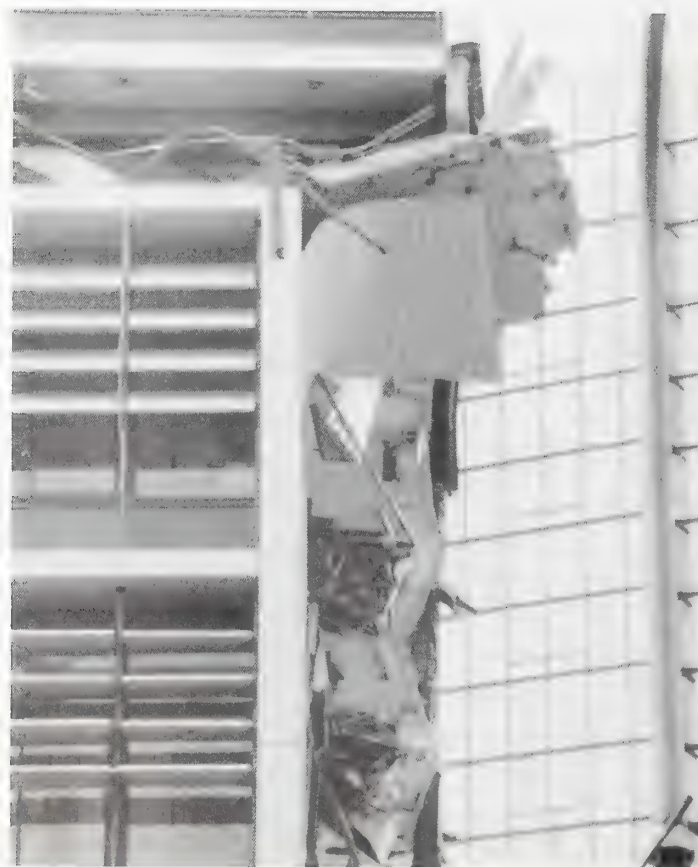
Figure 3.4.24 Collapsed upper story, north end - Kobe City Hall Annex.

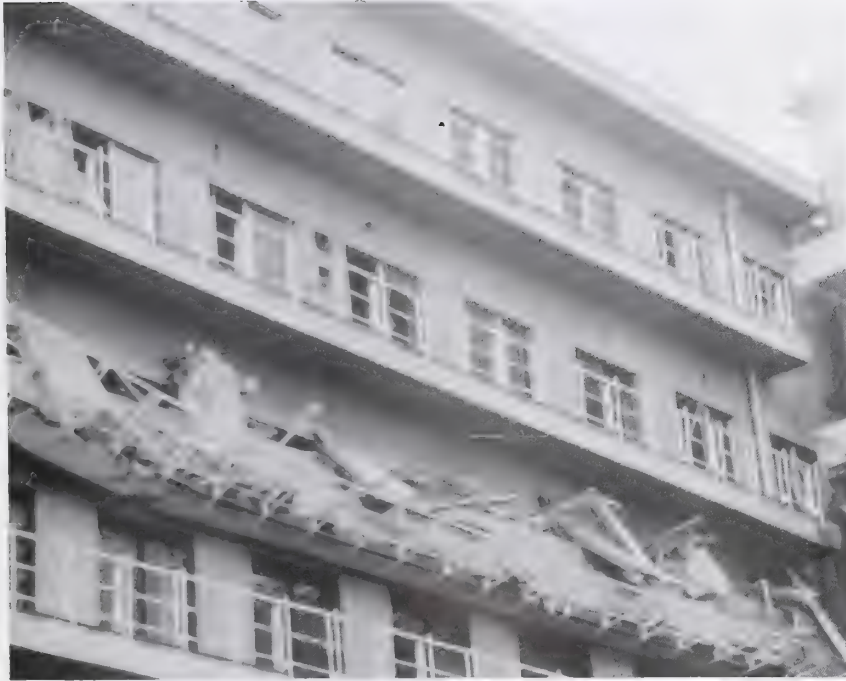
Figure 3.4.25 Collapsed upper story, northeast corner - West Kobe Citizens' Hospital.

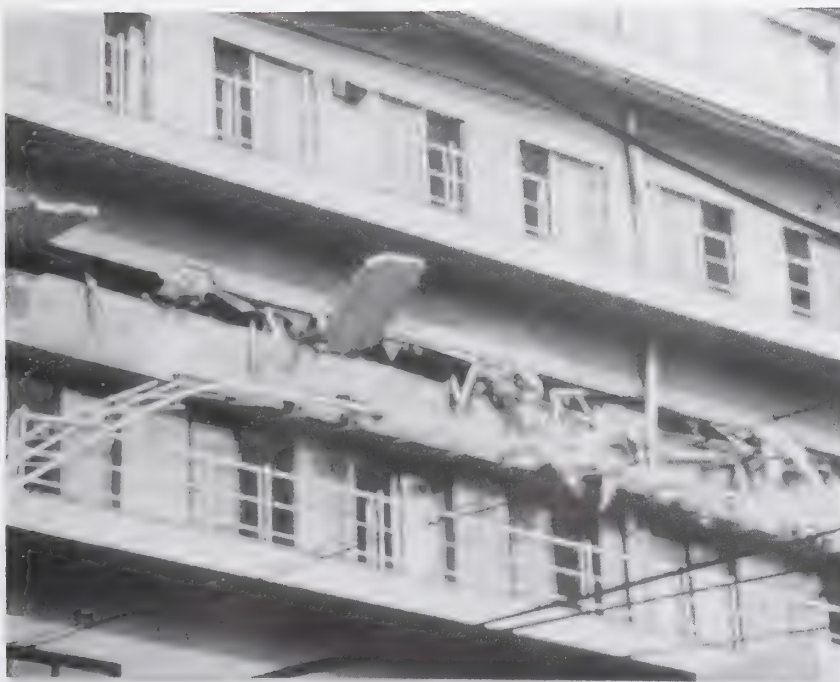
Figure 3.4.26 Collapsed upper story, northwest corner - West Kobe Citizens' Hospital.

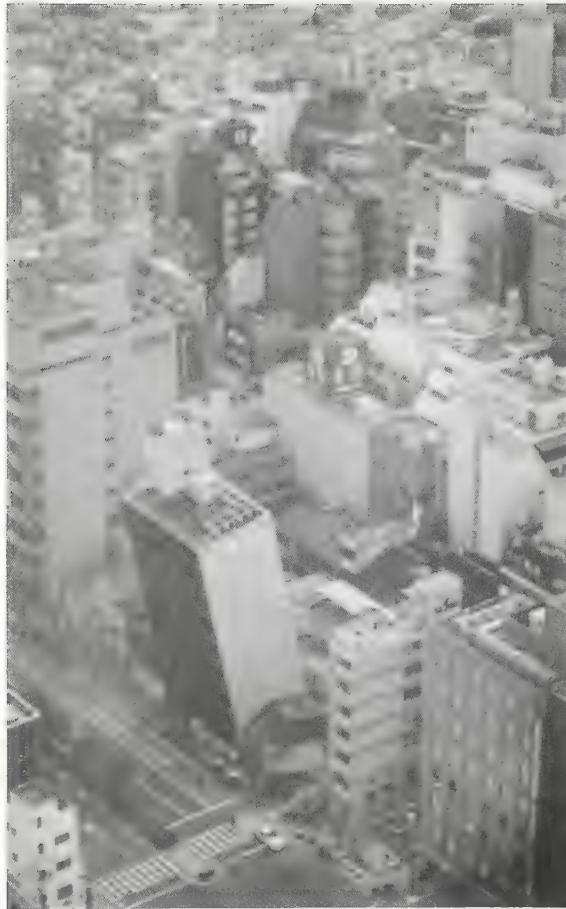
Figure 3.4.27 A leaning 9-story SRC building on Flower Road prior to total collapse.

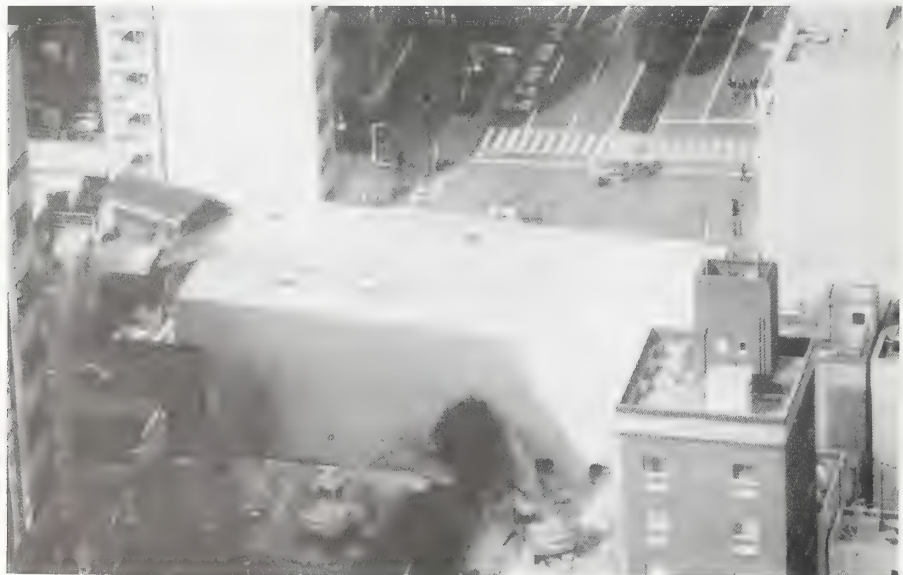
Figure 3.4.28 Totally collapsed building shown in Figure 3.4.27.

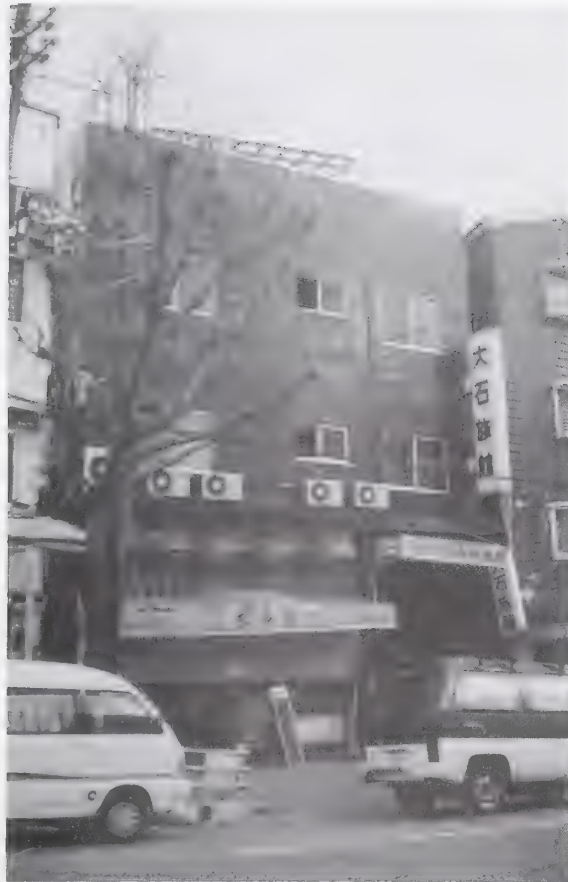
A large number of failures occurred in low rise steel frame structures constructed using light gage or cold formed steel. These were popular forms of construction in the 1960's when there were shortages of steel for general construction in Japan. In almost all cases, these were older (pre-1971) buildings with less than three stories and typically exhibiting significant corrosion and rusting (See Figures 3.5.6 and 3.5.7). The degree of corrosion in these older steel structures was surprising, despite evidence that the steel had originally been shop painted (usually red or orange) and was covered by various layers of cladding. This corrosion may possibly be related to Kobe's location as a port city on

Figure 3.5.6 Three-story brick-faced light gage steel apartment. Has roll up door. Closeups (Fig 3.5.7) show that there is a great deal of rust at the connections at the second floor which connect 8 inch light gage wide flange columns. Rust clearly was at fault in the failure, not the steel frame itself... this is a common type of failure that seems peculiar to this form of light gage steel frame construction... perhaps it is the salt atmosphere of a port city that leads to such extensive corrosion.

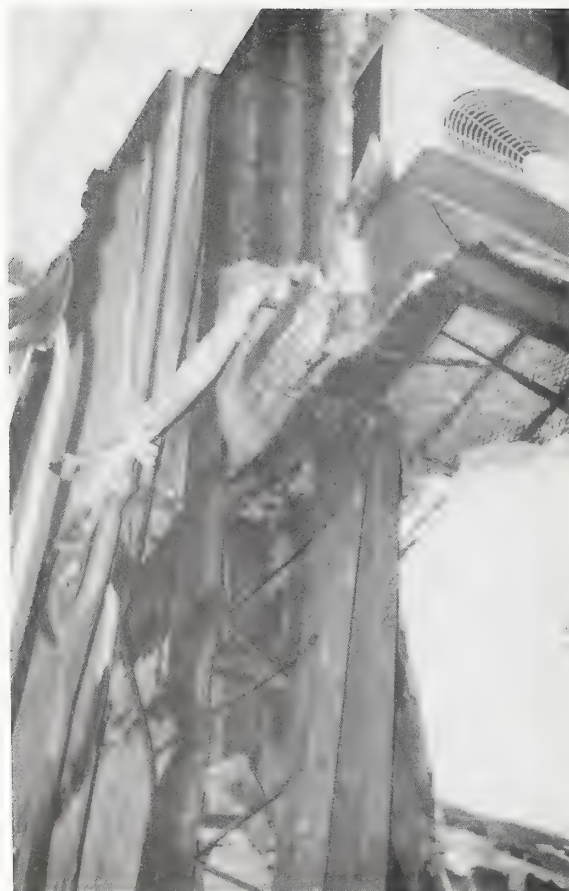
Figure 3.5.7 See caption for Figure 3.5.6: a closeup showing the rusted joint.

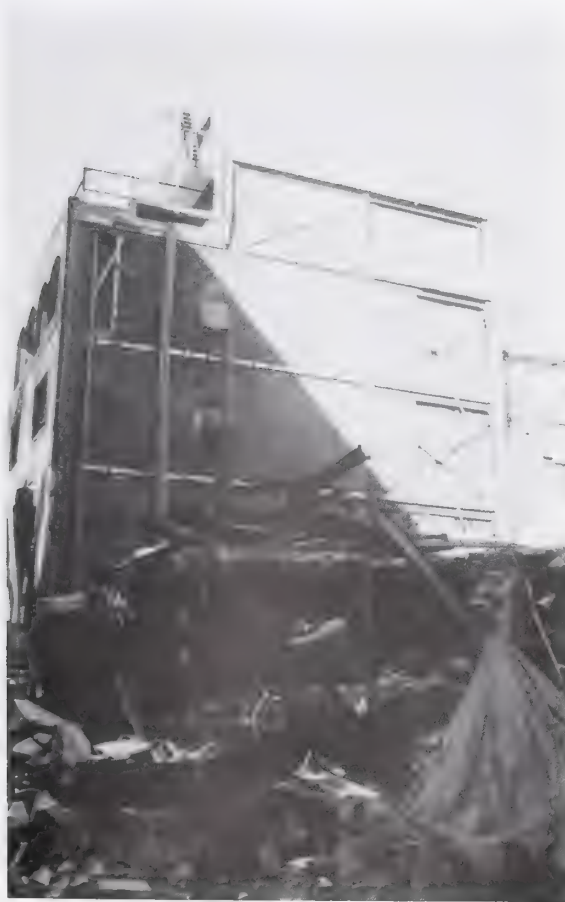
Figure 3.5.8 Braced steel frame, 5-story, in downtown Chuoku (Kobe). Masonry infill walls appear to have saved this structure while a neighboring structure did not fare as well.
